MOLD & MOISTURE REPORT

INSPECTION DATE: December 2, 2007; 3:00 p.m.

PROPERTY ADDRESS:
123 Mold Remediation Ave.
Mold City, CA 94618

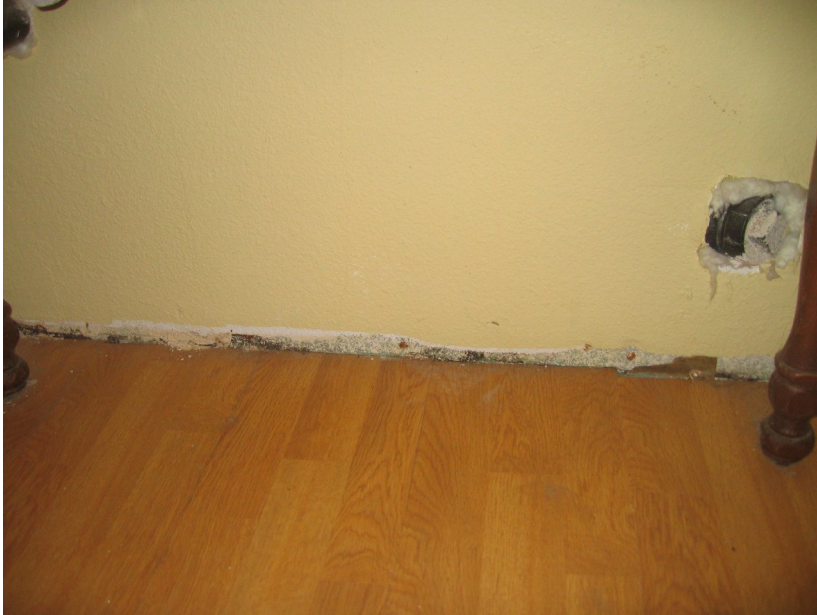
DOWNSTAIRS: There is some visible mold growth along the bottom of the drywall in the laundry room, hallway, and in the spare room adjacent to the laundry room. The majority of the drywall tested dry at 0.2%-0.3% moisture content with only a very small area that tested just slightly damp at 0.7% moisture content on the bottom of the drywall under the drain cleanout in the laundry room. There is also mold growth on the paper underlayment under the laminate wood floor and one very small area that showed some dampness.

Given the pattern of mold along the bottom of the drywall in the laundry room and hall and under the flooring, it would appear that the area had been subjected to some minor flooding in the past where there was enough water present to grow some mold before the moisture evaporated. At this time, there is not enough moisture present to sustain any more active mold growth.

Downstairs laundry room mold along bottom of wall:

The flooring in the laundry room should be pulled up and the room cleaned of mold. The flooring itself is may not be salvageable. The bottom 12" of drywall should also be removed and replaced. More may have to be replaced if there is visible mold in the wall cavities.

1. Have the mold in the downstairs remediated by a professional mold remediation company. Remove flooring and drywall per section 2 above.
2. Clean the very small patches mold from the kitchen using a detergent-based cleaner per EPA guidelines:
(<http://www.epa.gov/iaq/molds/cleanupguidelines.html>)
3. Investigate the source of the water under the kitchen sink.
4. Investigate the source of water in the garage and inspect for any structural damage as a result of the water intrusion.

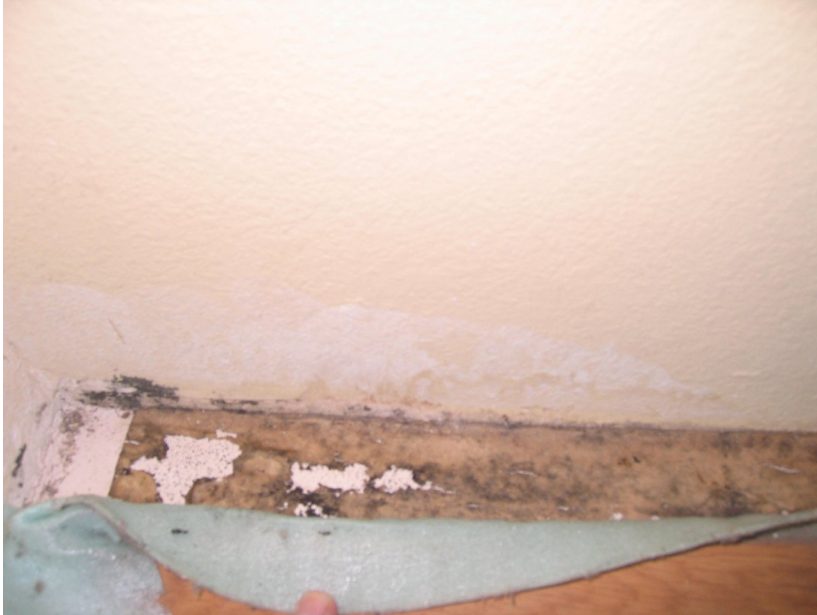
Downstairs laundry room mold under flooring and along bottom of wall:

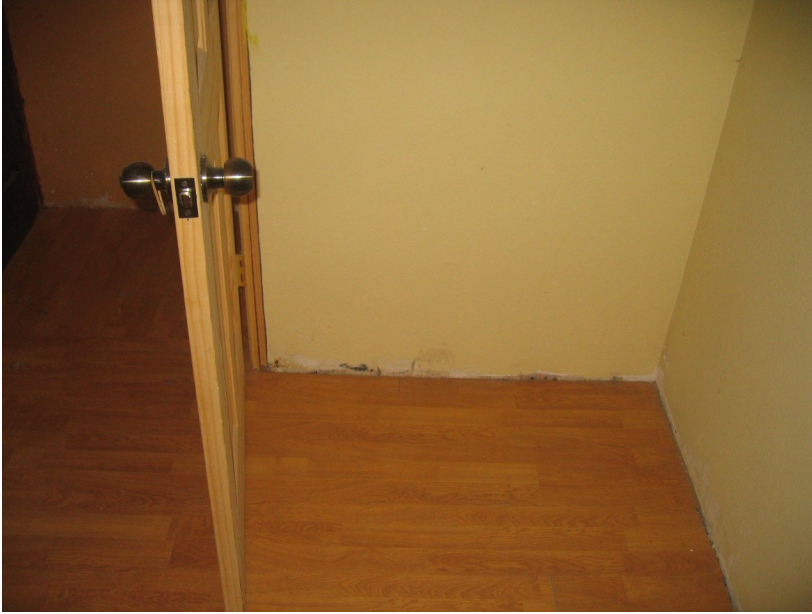
Downstairs hallway mold along bottom of wall:

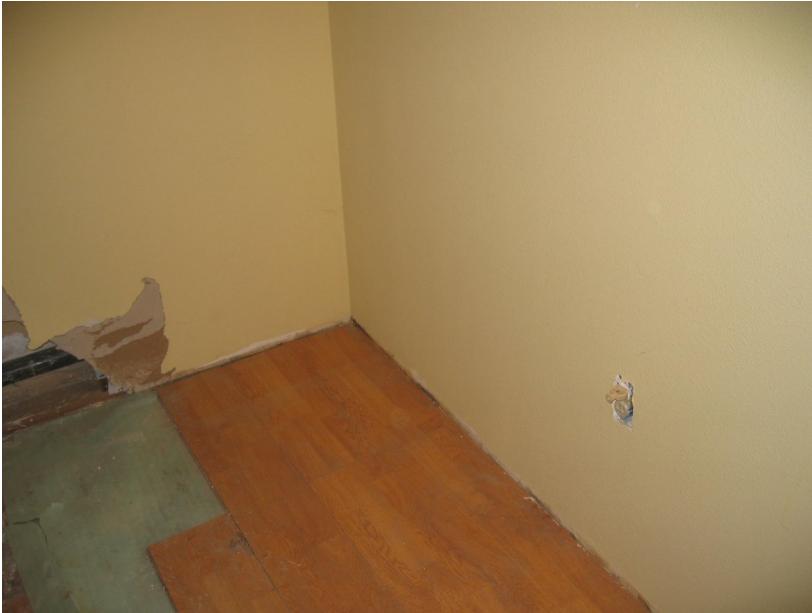
Downstairs spare room with mold along bottom of wall adjacent to laundry room:

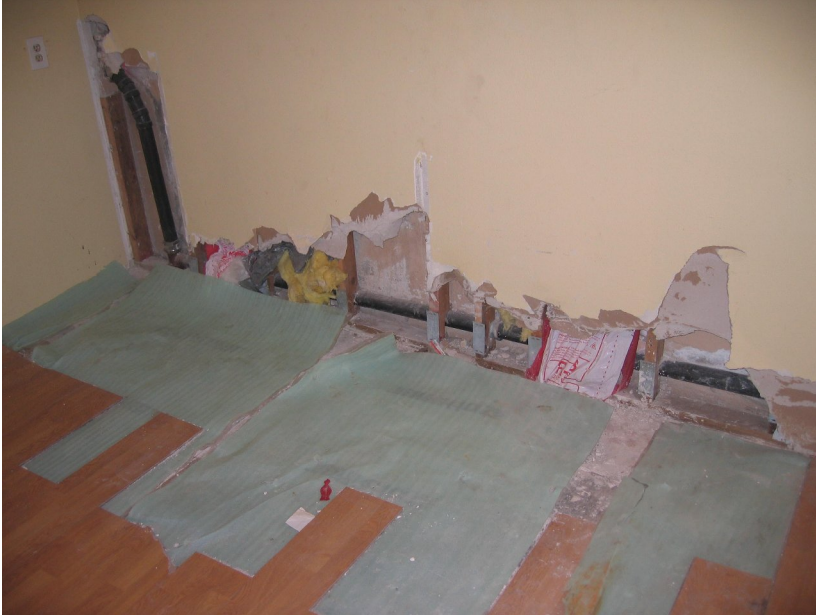
Downstairs spare room with drywall and flooring ripped up but no visible mold growth seen in this area.

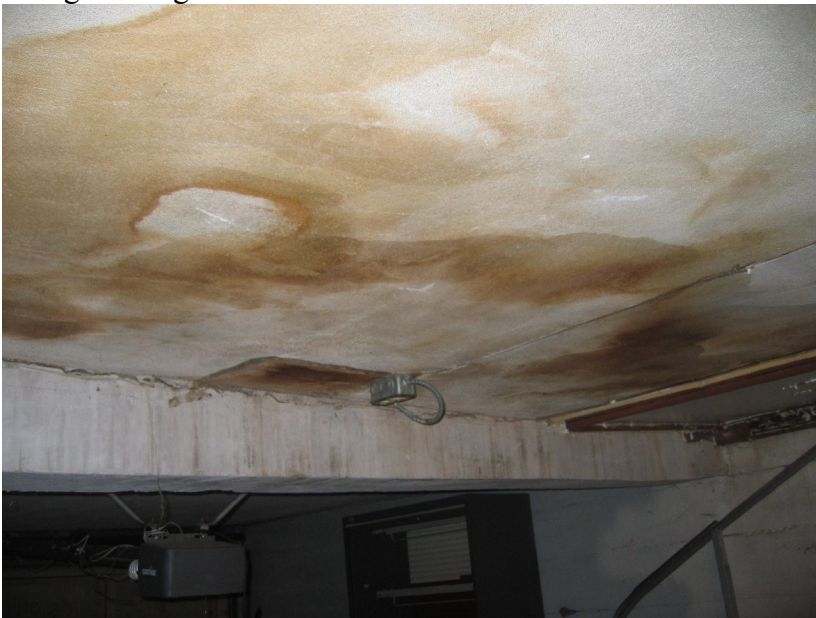
GARAGE: The garage has obvious water stains and one water saturated wood framing member with some water saturated drywall attached. Water may be coming through cracks from the tiled deck above. There was just a very small amount of visible mold growth on the small piece of saturated drywall. The ceiling cavity above the water stains could not be viewed and may be a potential mold issue or water damage issue that could undermine the integrity of the ceiling. This is unknown and should be inspected by a qualified contractor for structural soundness and water tightness.

Garage ceiling with severe water stains

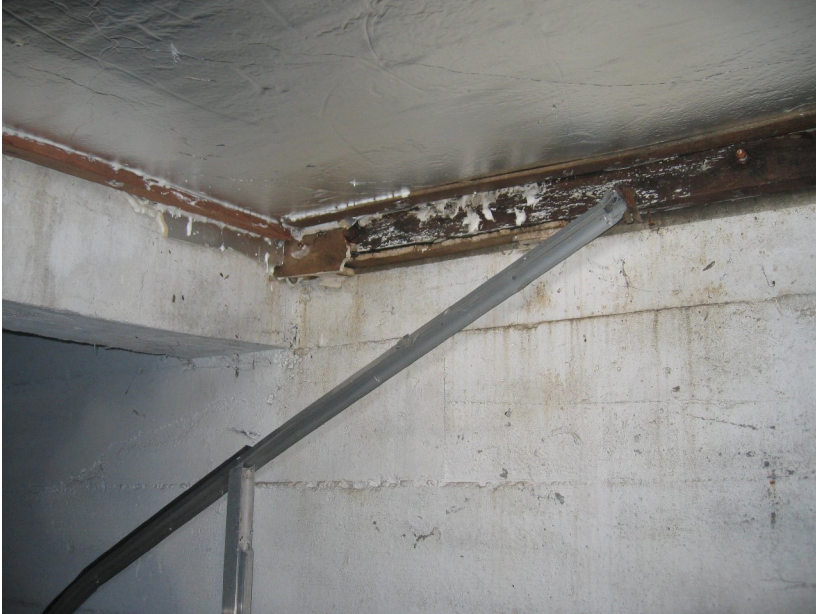
Garage wall with water saturated wood framing member at ceiling.

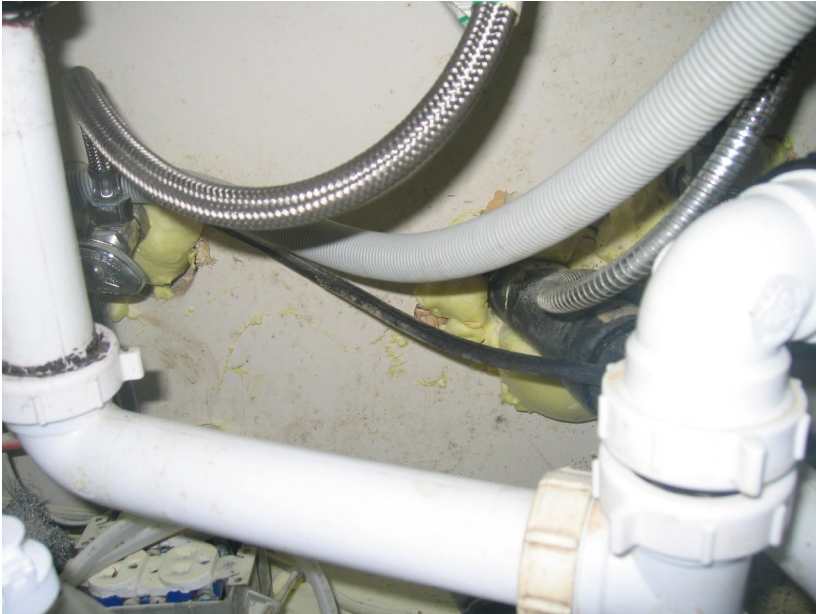
KITCHEN: There is a very minor amount of mold growth on the drywall just above the counter top behind the secondary sink; this area is completely dry. There is also a very minor amount of mold on the inside back of the cabinets under the main sink. This area under the main sink still contains some moisture which may cause the mold to continue growing. The source of the moisture is not clear as to whether it is from an ongoing leak or from some other one-time occurrence that has not yet fully dried out.

Under main kitchen sink back wall is damp with very small mold growth:

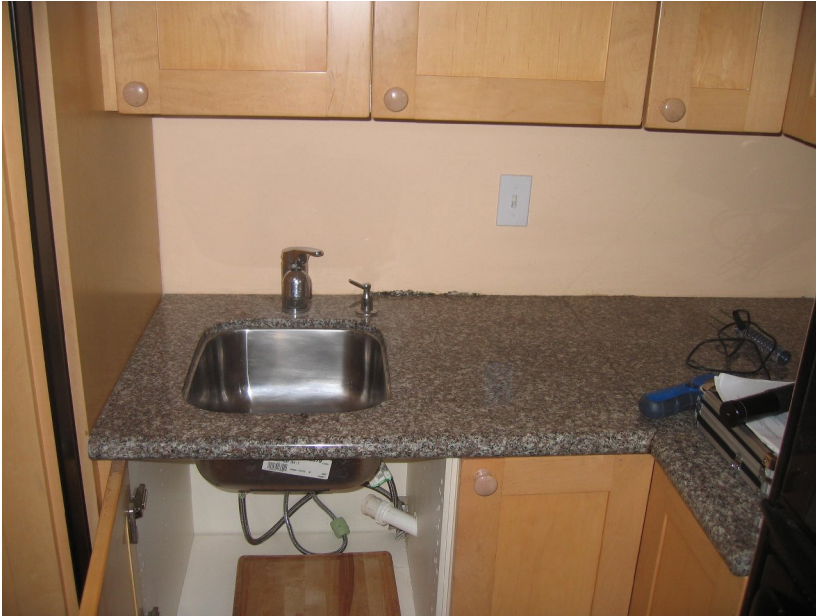
Secondary kitchen sink with mold on wall just above counter:
